**Plant and Eurasian Watermilfoil Weevil Survey
Sanctuary Pond at Prairie Crossing
8/25/06**

Eurasian Watermilfoil Weevil Survey

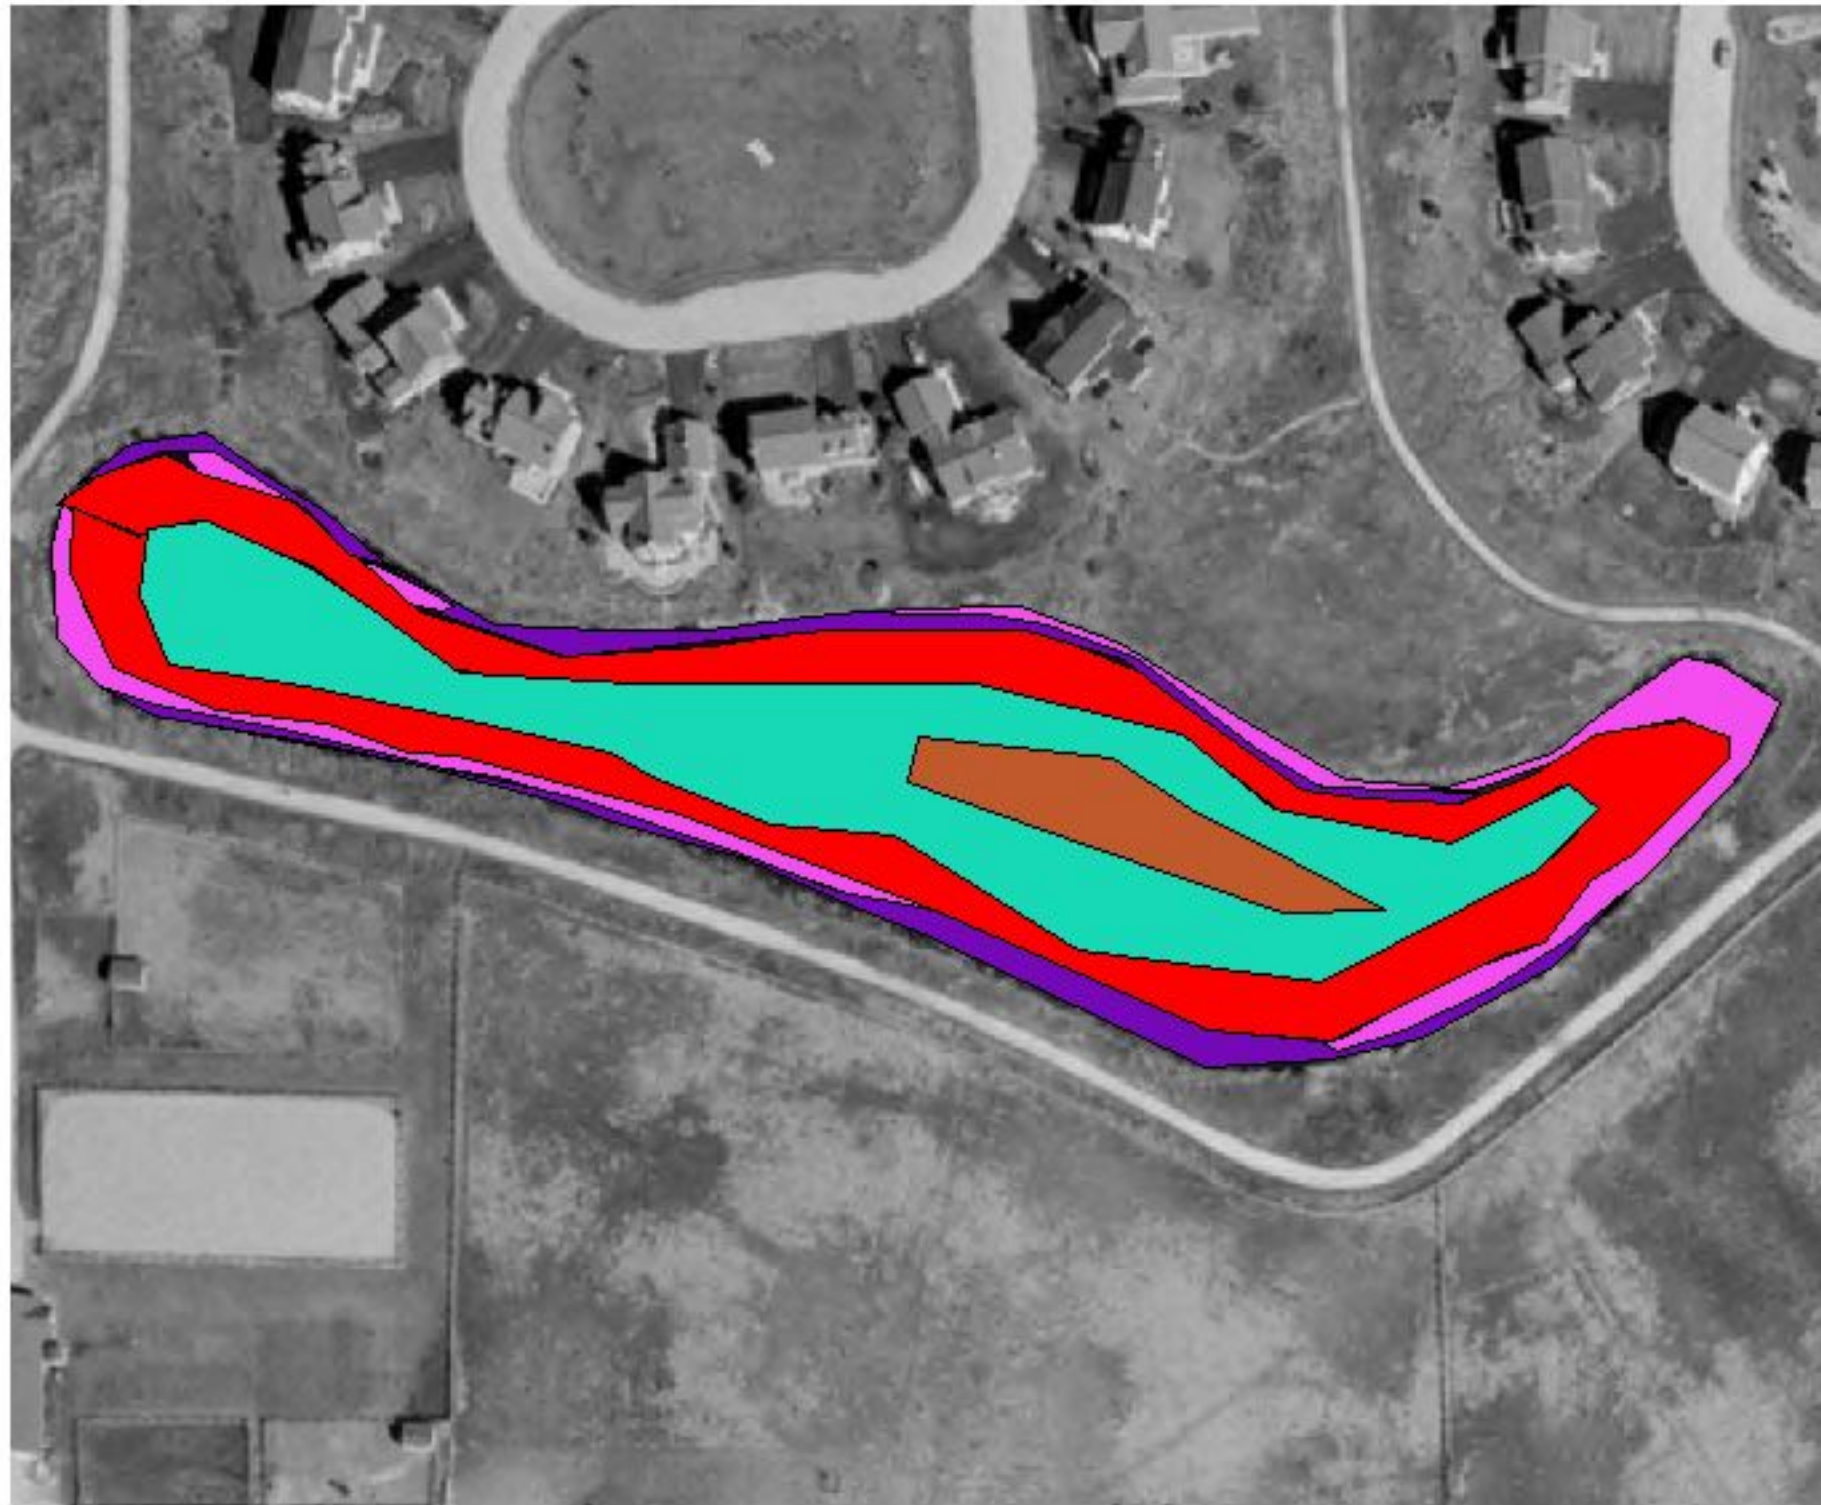
Sanctuary Pond Plant Survey, 8/25/06

- American pondweed.shp
- Scattered sago pondweed shp.shp
- Coontail.shp
- Ewm.shp
- Whitewater lilies.shp

Location of plant species are approximate. Chara was underneath shoreline plants. Horned pondweed was minimal.
