Integrated Lakes Management
Environmental Quality Workshop
Prairie Crossing
2007

History of Studies at Lake Leopold – performed by ILM

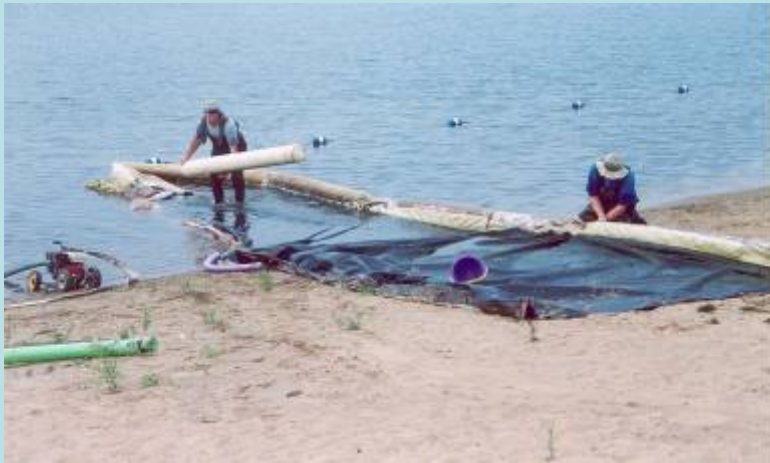
Aquatic Herbicides - Limited Areas

- **Sediment Curtain**
 - Works great!
- **Limited areas**

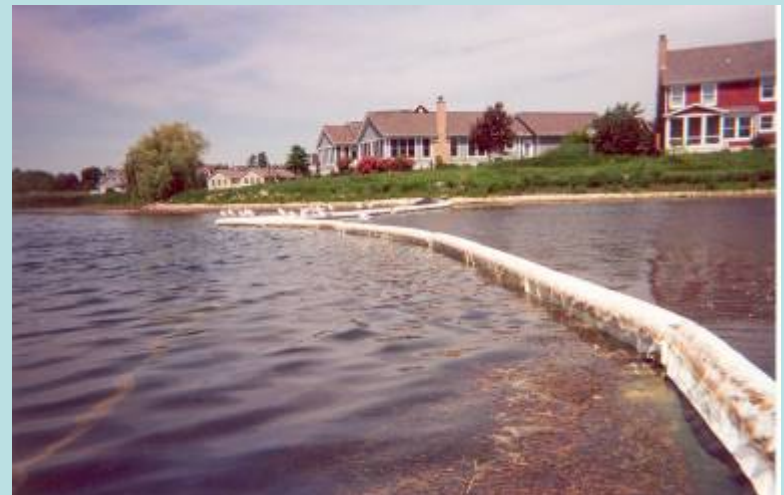
Target species

- **Curly leaf pondweed**
- **Eurasian watermilfoil**
 - Early season treatment prior to native emergence

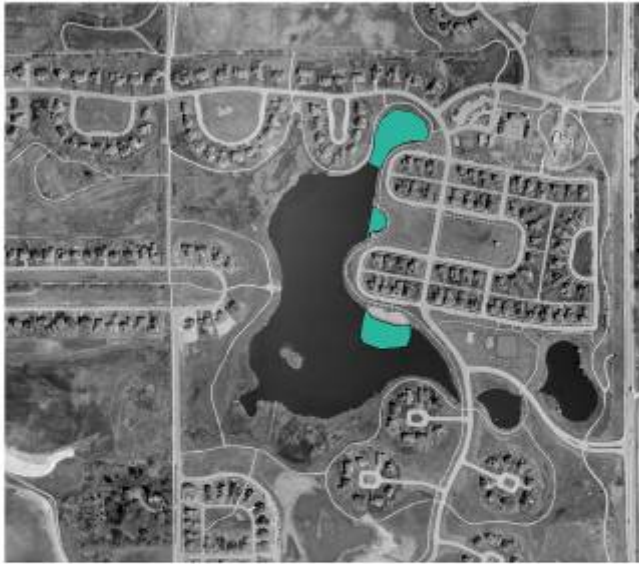
Proposed Herbicide Areas 2007

- Herbicide areas where no plants are wanted
 - Beach
 - Fishing areas
- Herbicide North Bay to control extensive plant growth
- 1 treatment worked great at the beach!
- Plant N. Bay with desirable species

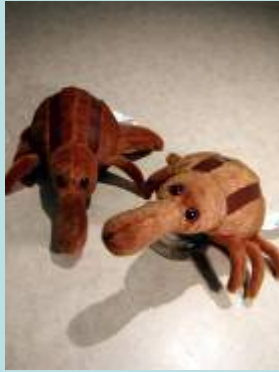
Installed over 6,000
EWM Weevils in 2006
to control
Eurasian watermilfoil
(EWM)

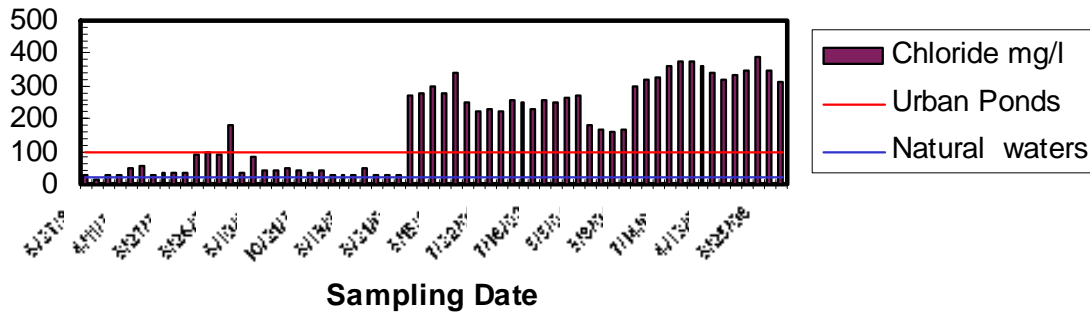
**Chloride Concentrations 1995 - 2006:
Lake Leopold**

- 11 Years of data
 - Proposed for 2007
 - Continue water quality monitoring
 - Lake management plan

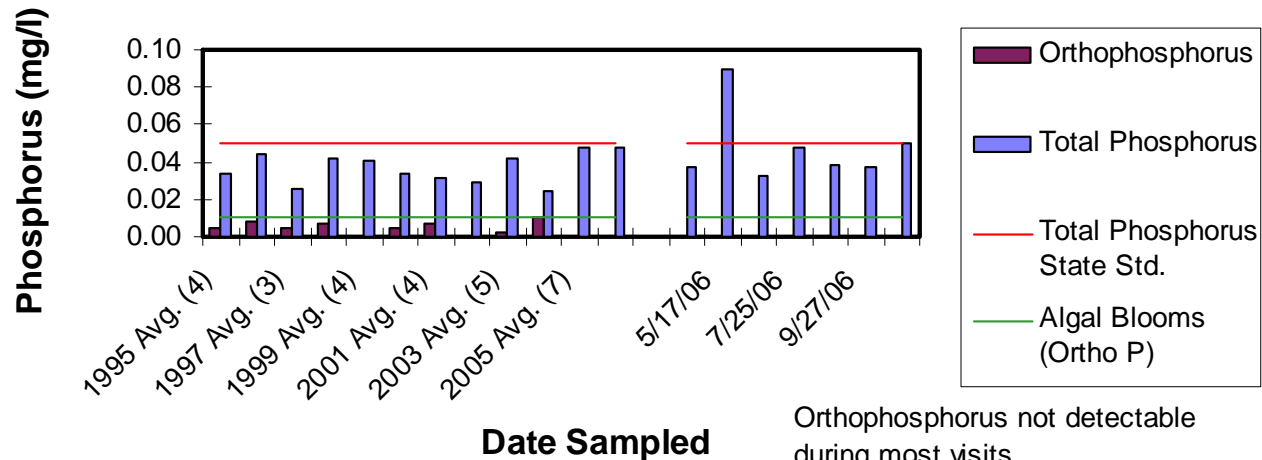
Phosphorus Concentrations: Lake Leopold

Orthophosphorus not detectable during most visits.

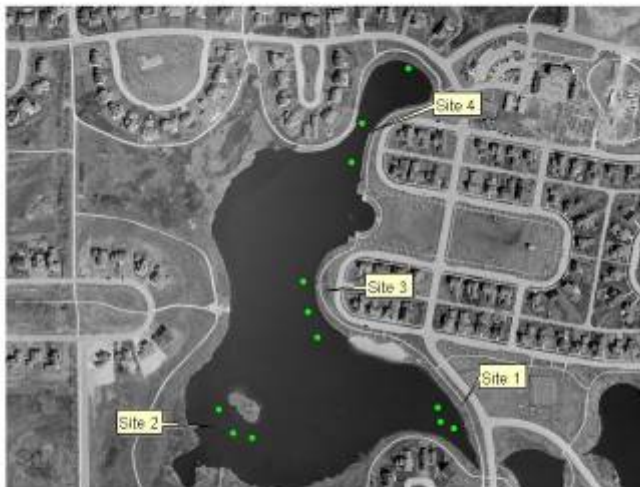
**Sediment Sampling Locations
August 11, 2006**

- **Determine if sediment chemistry favors EWM or CLP**
- **Chemistry favors EWM**
- **Sediment nutrients fairly low**

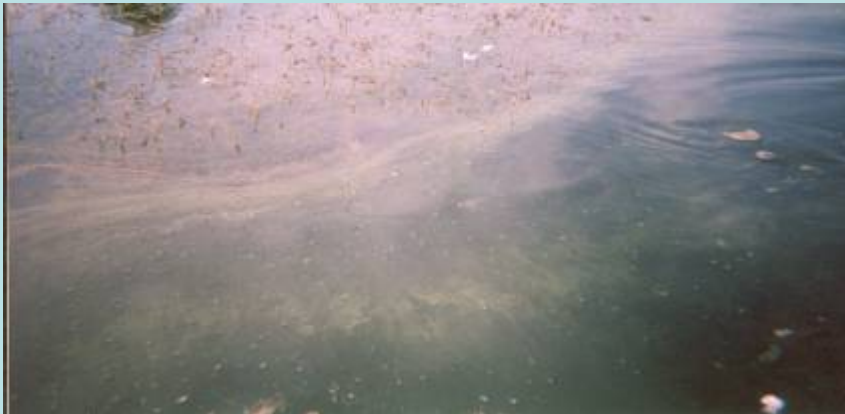
- Periodic blue-green algal blooms
- Toxicity testing available if needed

- Toxins affect animals & people that drink the water.

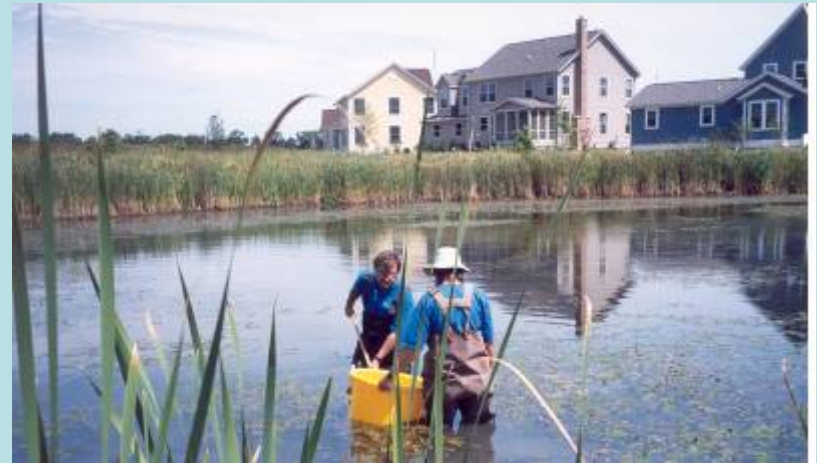
- Surveyed last 3 years
- Bluegills dominant
- E/T fish larger than in pond, but less common

- Recommend yearly fish surveys

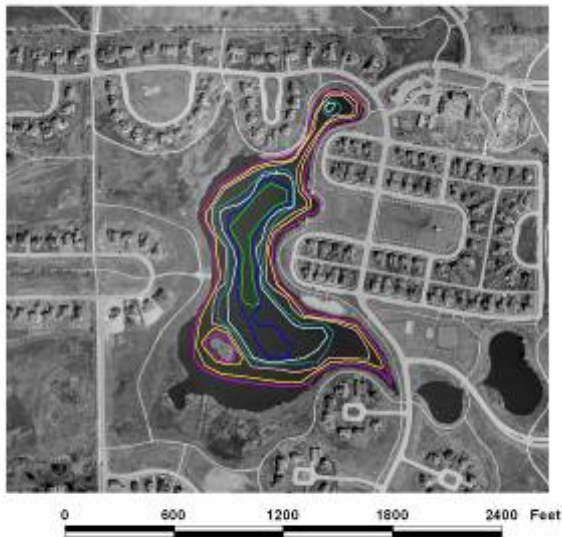
Lake Leopold Bathymetric Map
October 4, 2005

Isopleths based on interpolation between points probed with a 1.5 inch diameter PVC pole graduated in tenths of a foot. Map is based on 144 data points and should be regarded with some margin of error.

- 14 ft isopleth.shp
- 12 ft isopleth.shp
- 10 ft isopleth.shp
- 8 ft isopleth.shp
- 6 ft isopleth.shp
- 4 ft isopleth.shp
- 2 ft isopleth.shp

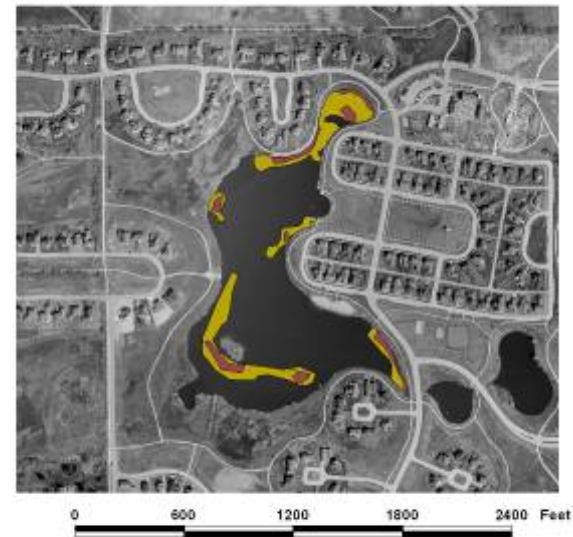
Lake Leopold Sediment Thickness Map
October 4, 2005

Sediment thickness is based on interpolation between points probed with a 1.5 inch diameter PVC pole graduated in tenths of a foot. Map is based on 144 data points and should be regarded with some margin of error.

- 1 ft sediment.shp
- Half ft sediment.shp

Repeat every 10 years
